Lake Mattamuskeet Watershed Restoration Plan

October 16, 2018 Public Meeting

Flow Reduction of Lake Mattamuskeet Outlet Canals

The Hydrological Modeling of Lake Mattamuskeet

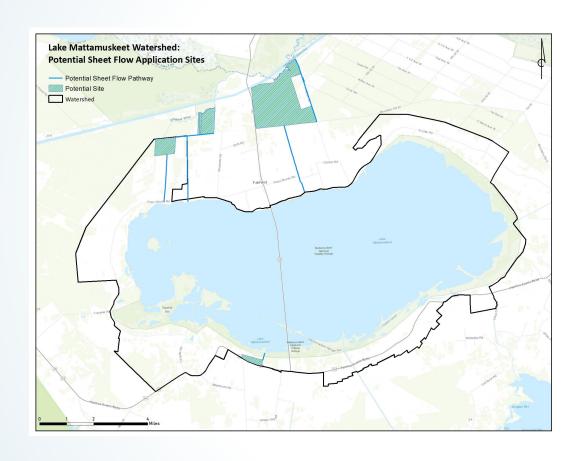
Potential Sheet Flow Sites

378 acres within watershed

2,477 acres outside watershed

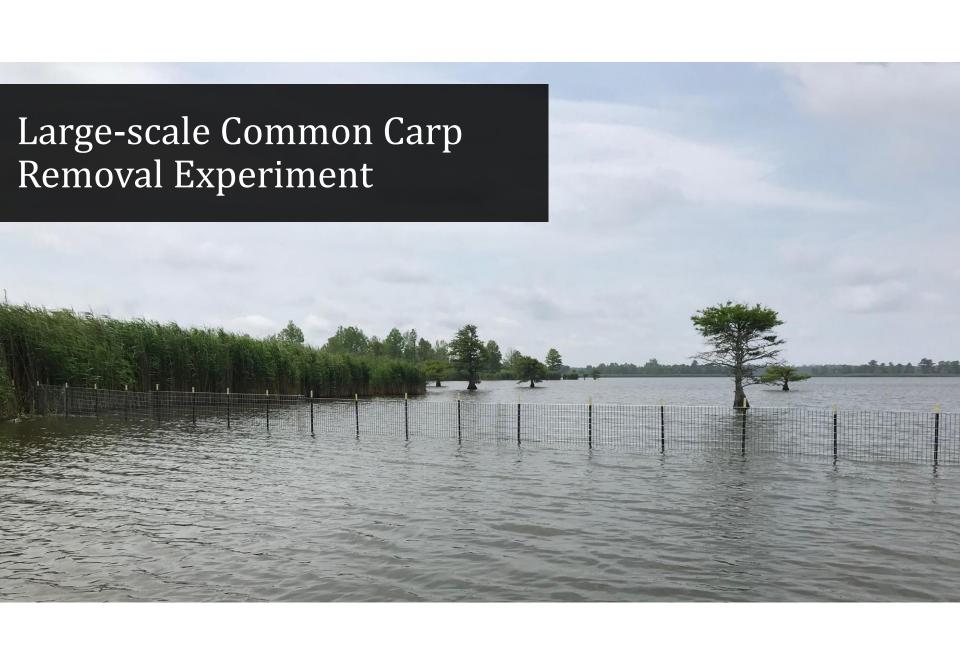
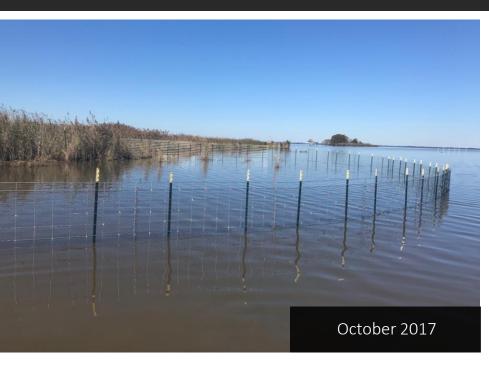
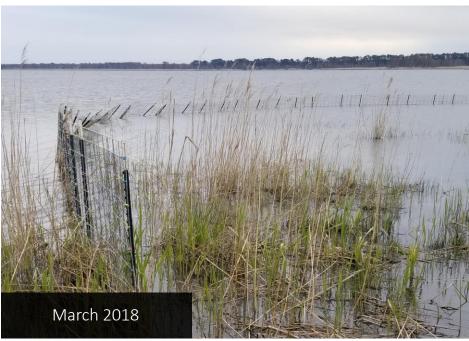
Prototype carp fence (Oct 2017 – March 2018)

- Constructed using galvanized steel cattle panels
- Panels attached using wire connectors and overlaid with chicken wire using zip-ties
- Left standing overwinter to test structural integrity of materials

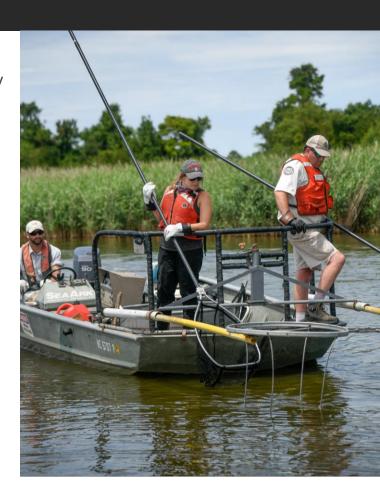
How many carp are in the bay?

- Simple mark-recapture to estimate population density
- 200 fish captured from outside experimental bay
- Fish were marked via a caudal, or tail, fin clip
- Fish were held for 24 hours before being released in NE, NW, SE, SW corners of the bay
- Then given a 48 hour adjustment period before recapture attempt

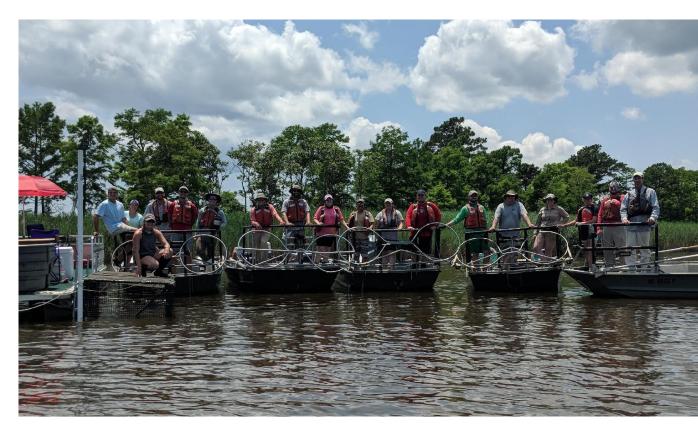
- Three days
- Five electrofishing boats
- Seven WRC biologist from five districts
- 15+ volunteers from NC State, Mattamuskeet NWR, and Pocosin Lakes NWR
- 33 Total hours of "pedaldown" time

Density Estimate - Results

Day	Effort (hours)	Captures	Average Weight (kg)	Average Length (mm)	Recaptures
1	10.01	78	2.07	538.2	8
2	11.25	68	2.09	545.0	1
3	12.22	61	2.13	545.0	3
Total	33.48	207	2.09	542.4	12

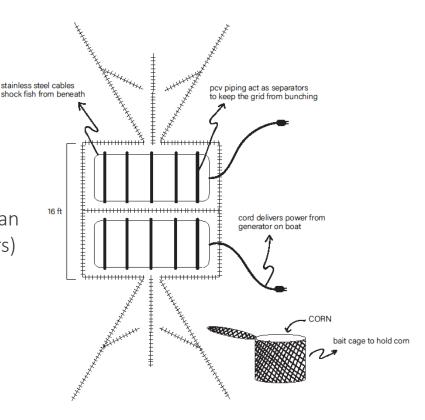
Removal Alternatives

- Currently, we're baiting "carp traps" with deer corn to specifically target Common Carp
 - Two traps to date, but more will be built
 - Only Common Carp and catfish will eat corn
 - Will be modifying to limit corn loss and chance of an encounter from unwanted predators (e.g. alligators)
 - Alternative bait options: dog food, soybean cake

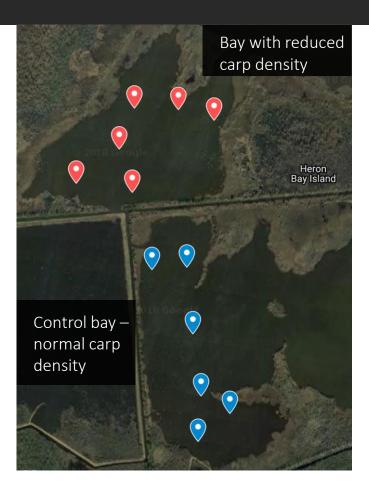
Water Quality Monitoring

- Sampling sites chosen randomly in ArcGIS under given constraints
 - 50 m from documented osprey nests
 - 10 m from shore

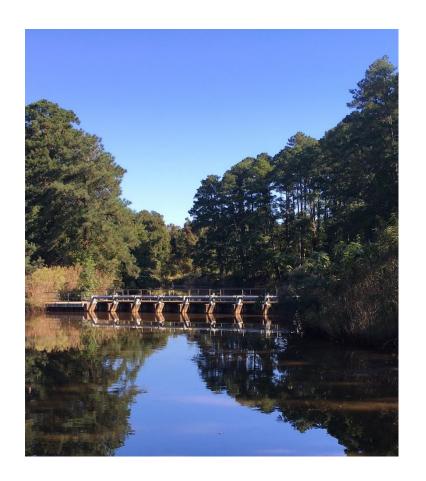
Tide Gates

- Flow occurs only when water level in the lake is above water level in the sound
- Dredging will have minimal impact on when tide gates are open

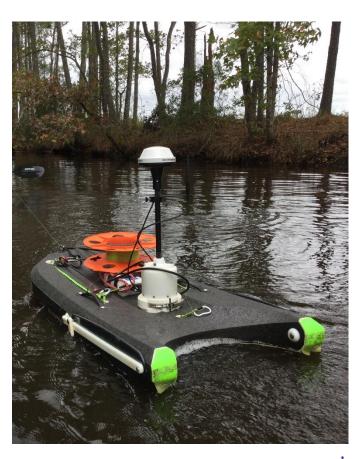
Methods

- Current flow rates acoustic Doppler profiler
- Model: HEC-RAS from U.S. Army Corps of Engineers
- Hurricane simulation:
 Water balance

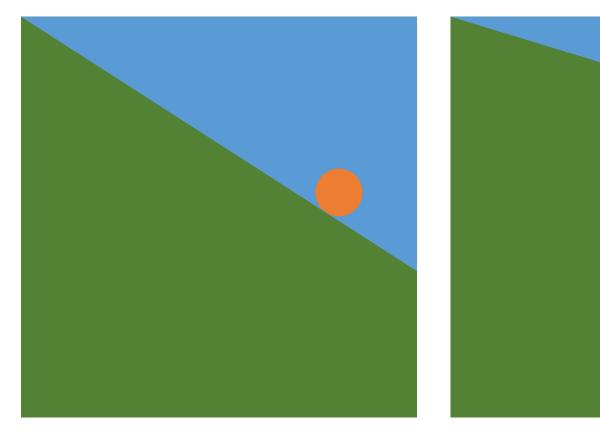
Sea Level Rise

49% Reduction

in flow due to 2 ft rise in sea level even if canals are dredged

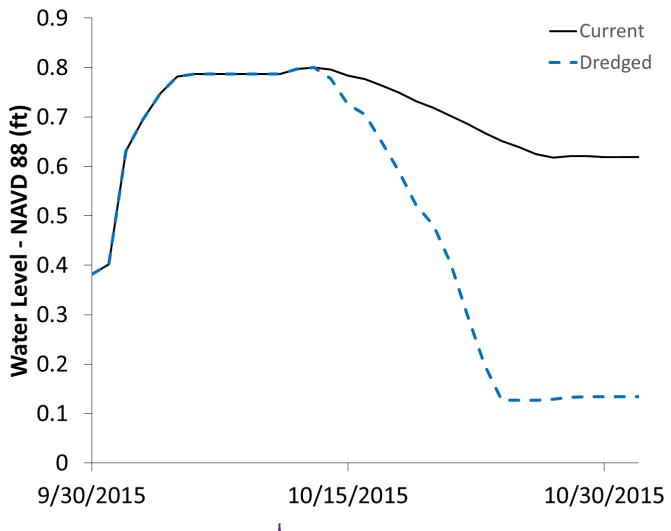
Results – Hurricane Joaquin

- Hurricane Joaquin number of days before water level drops below 0.7 ft
 - Current canals: 22 days
 - Simulated dredged canals: 17 days
- Hurricane Matthew number of days before water level drops below 0.9 ft
 - Current canals: 47 days
 - Simulated dredged canals: 21 days

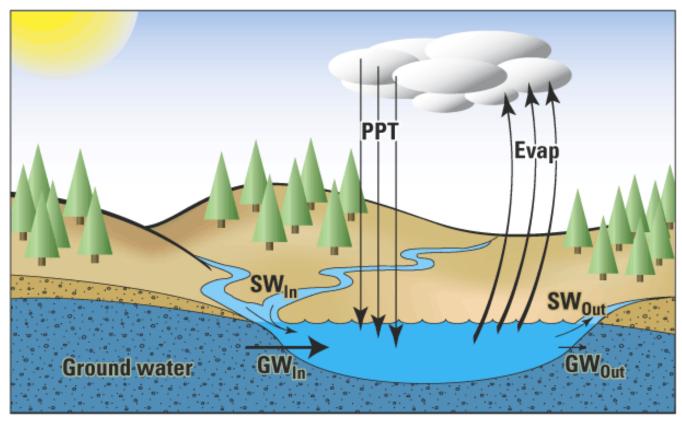
Hydrologic Balance of a Lake

Evap	Evaporation
GW _{In}	Ground-water inflow
GW _{Out}	Ground-water outflow
PPT	Precipitation
SWIn	Surface-water inflow
SWout	Surface-water outflow

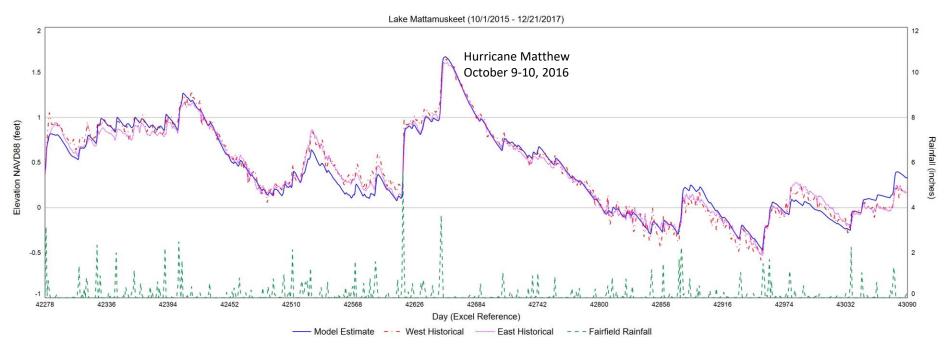
Preliminary Model Dynamics

(unvalidated model 8/1/2018)

Lake Mattamuskeet - Stage Level (feet)
