## Living Shoreline Design Guidelines for Shore Protection in Virginia's Estuarine Environments

# ***Living Shoreline Design Guidelines for Shore Protection in Virginia's Estuarine Environments***

***Version 2.0***

***Special Report in Applied Marine Science and  
Ocean Engineering #463***

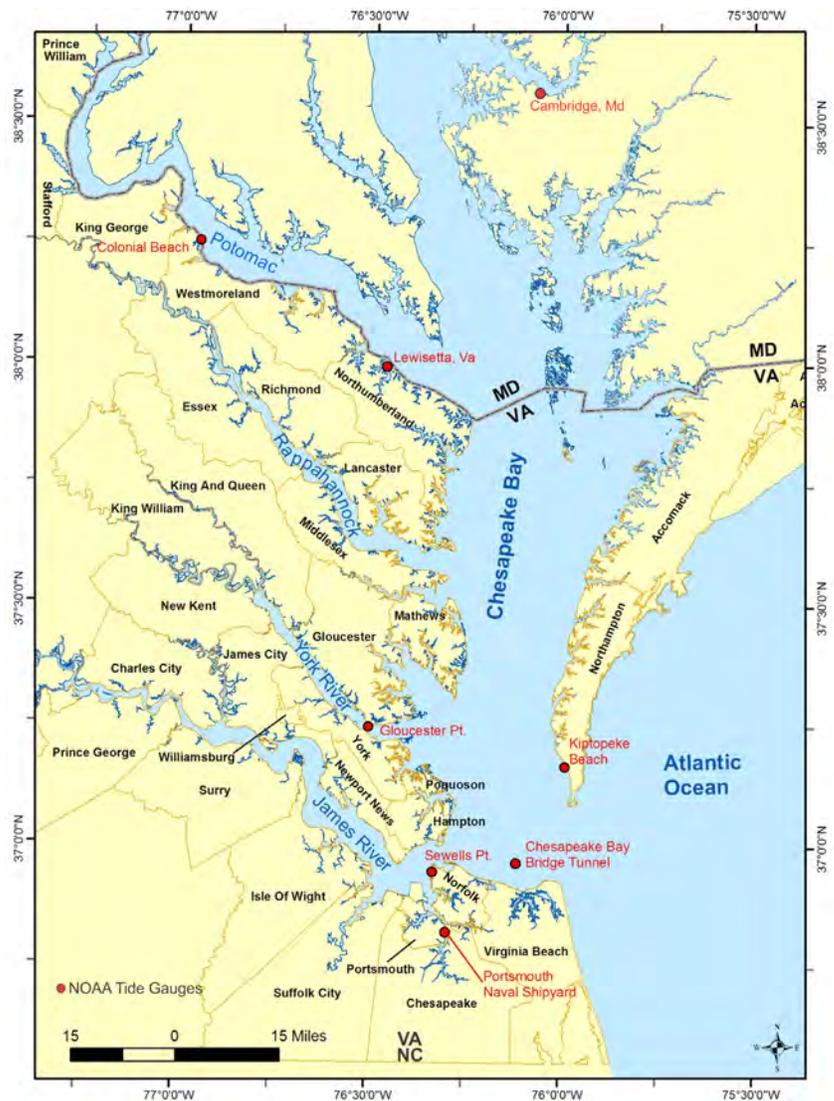
Figure 1-1. Virginia portion of the Chesapeake Bay estuary and location of tide gauges.

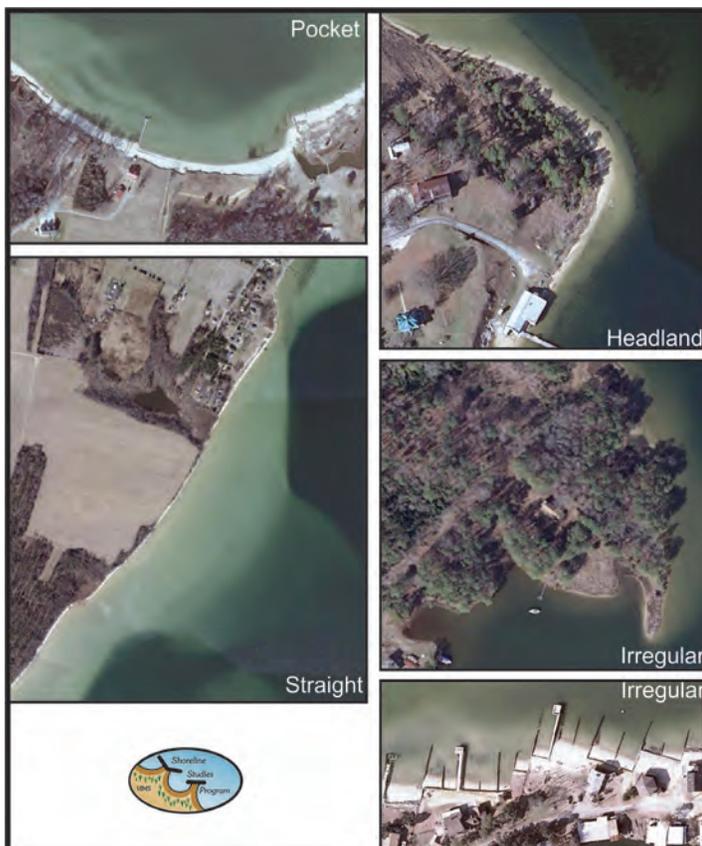
Figure 2-2. Photos illustrating four different types of shore morphology within Chesapeake Bay. Photos: VGIN 2009.

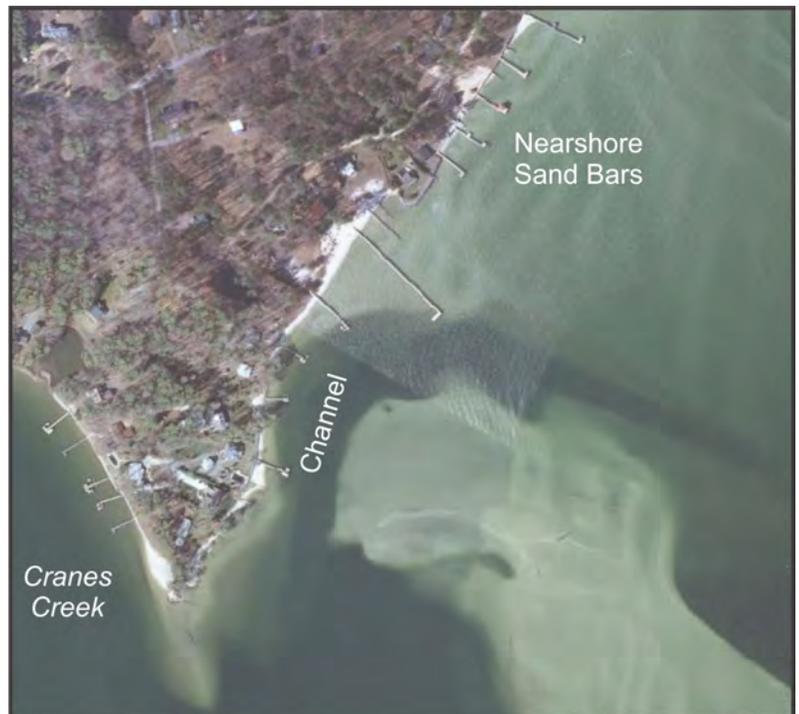
Figure 2-4. A VGIN 2009 photo shows the channel into Cranes Creek in Northumberland County, Virginia. Sand bars north of the channel will attenuate waves while the shoreline adjacent to the channel has no bars and will feel the full effect of the waves impacting the shoreline.

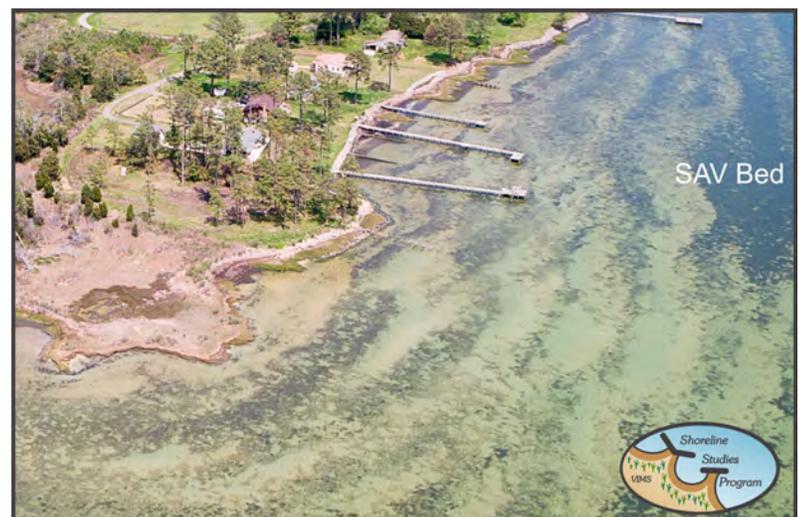
Figure 2-5. A VIMS aerial photo of Pond Point on the East River in Mathews, Virginia (dated 21 April 2009) showing extensive SAV in the nearshore, as well as sand bars.

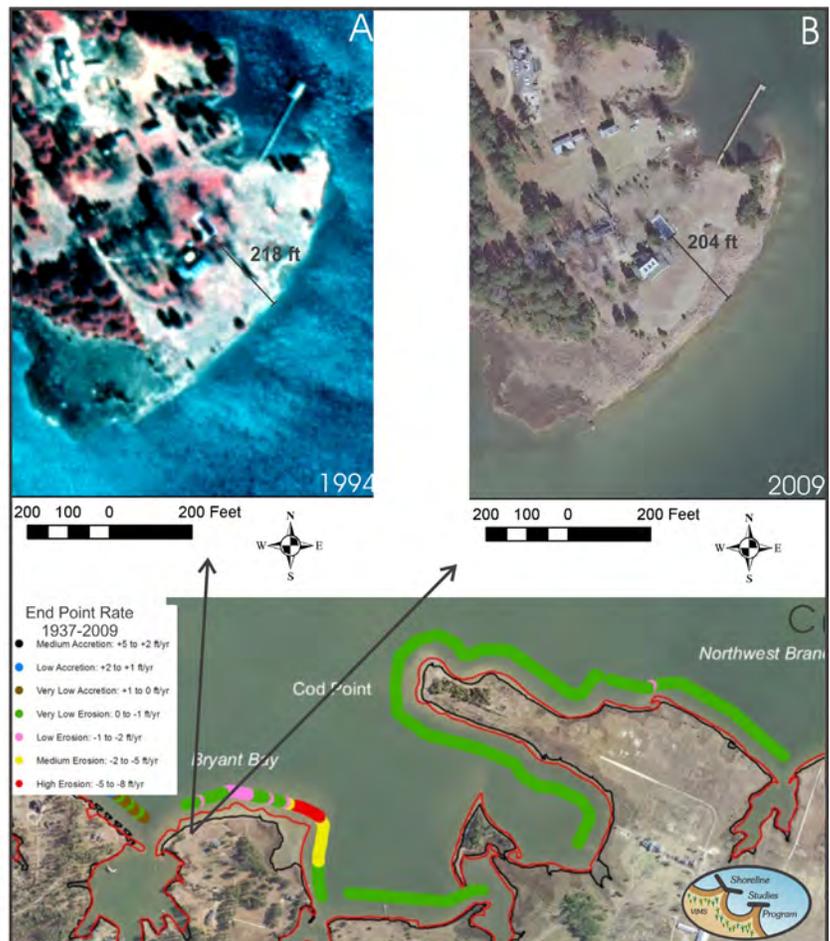
Figure 2-7. Determining rate of change along the shoreline. Aerial photos of a site in Gloucester County in A) 1994 and B) 2009. C) The end point rate of shoreline change determined between 1937 and 2009. Rates are visualized as different colored dots and show the variability of rates of change along small sections of shore (from Milligan *et al.*, 2010).

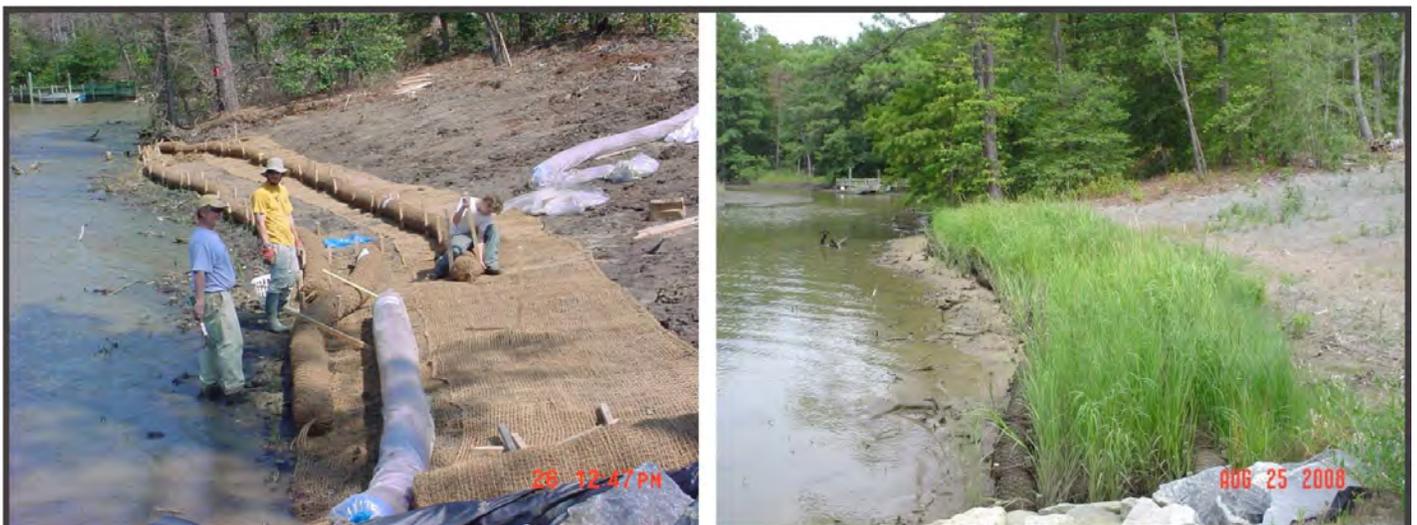
*Figure 3-2. Coir logs and mats placed at toe of a graded bank for temporary stabilization while planted tidal marsh and riparian buffer become established. Photos by P. Menichino.*

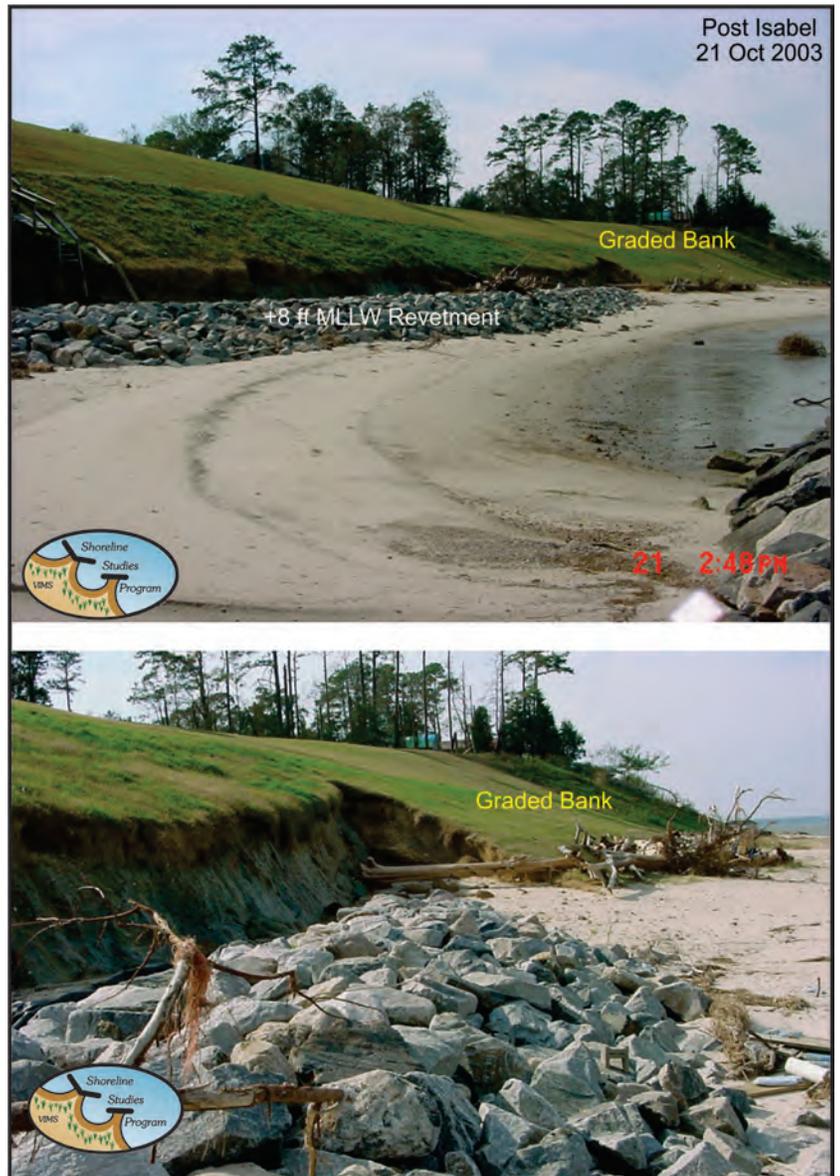
Figure 3-9. Revetment on the James River that was overtopped by storm surge and waves during Hurricane Isabel. Photo dates 21 October 2003.

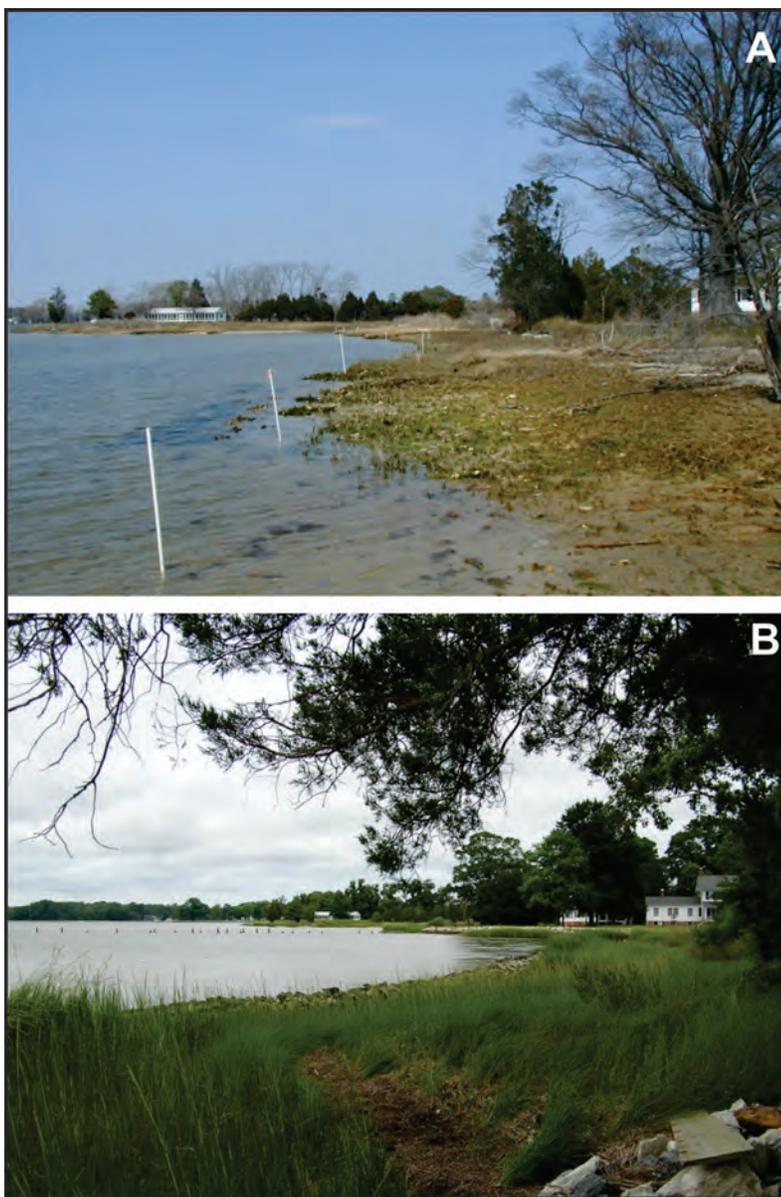
Figure 4-2. Hollerith marsh toe revetment/sill site A) before project with eroding fringing marsh in winter and B) after construction.

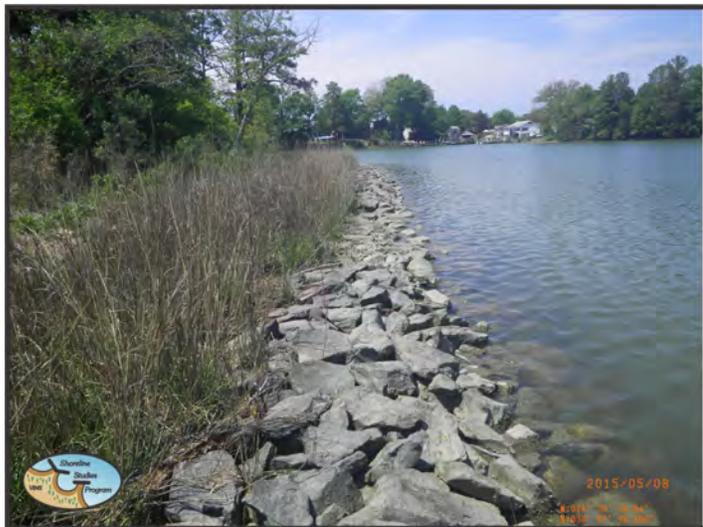
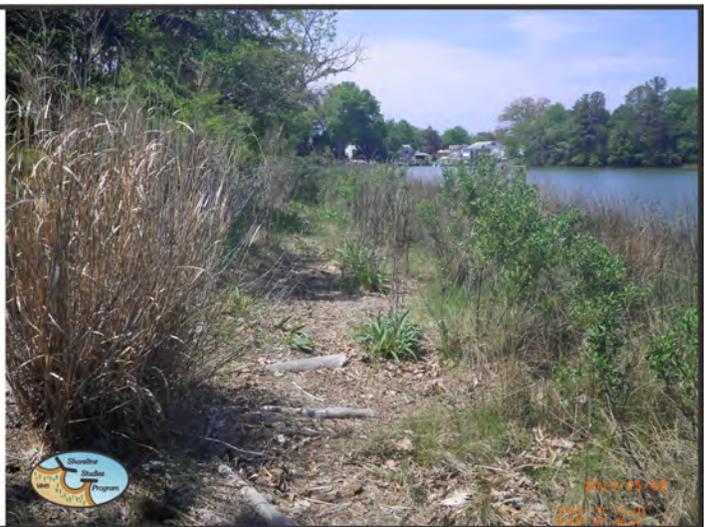
Figure 4-10. Photos of Hull Springs Farm in May 2015, seven years after construction.

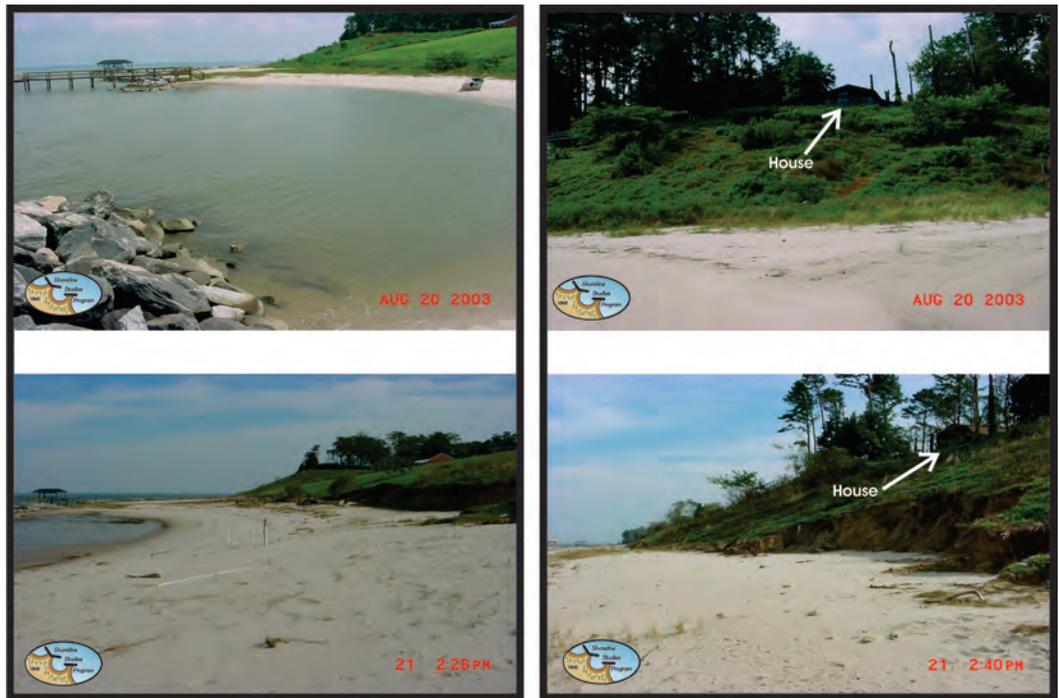
Figure 4-12. Van Dyke ground photos before (top) and after (bottom) Hurricane Isabel (from Hardaway et al., 2005).

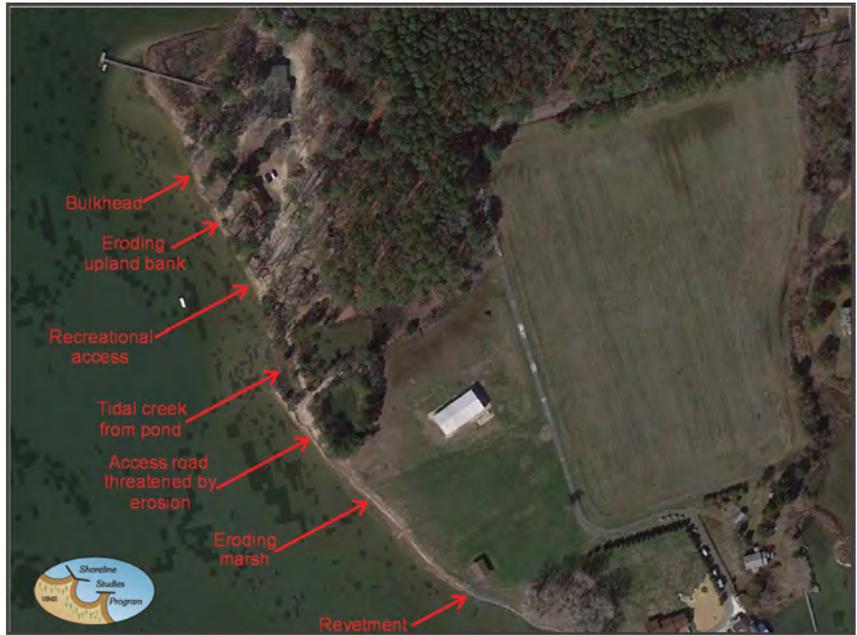
Figure 5-2. Considerations for shore protection design along the project area.

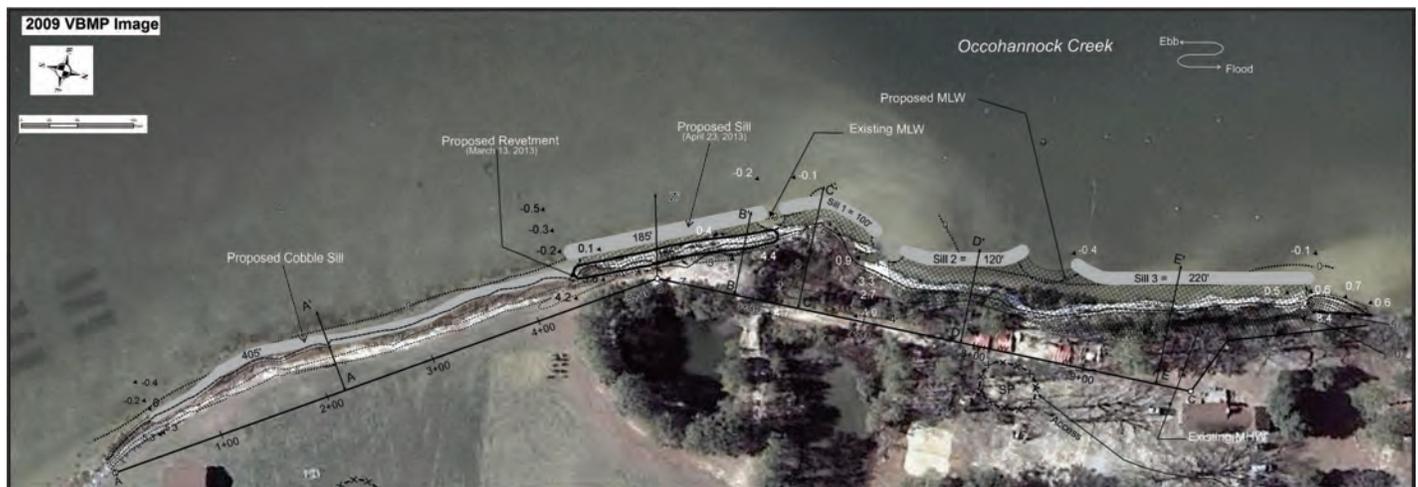
Figure 5-3. Design for shore structures at Occohannock on the Bay.

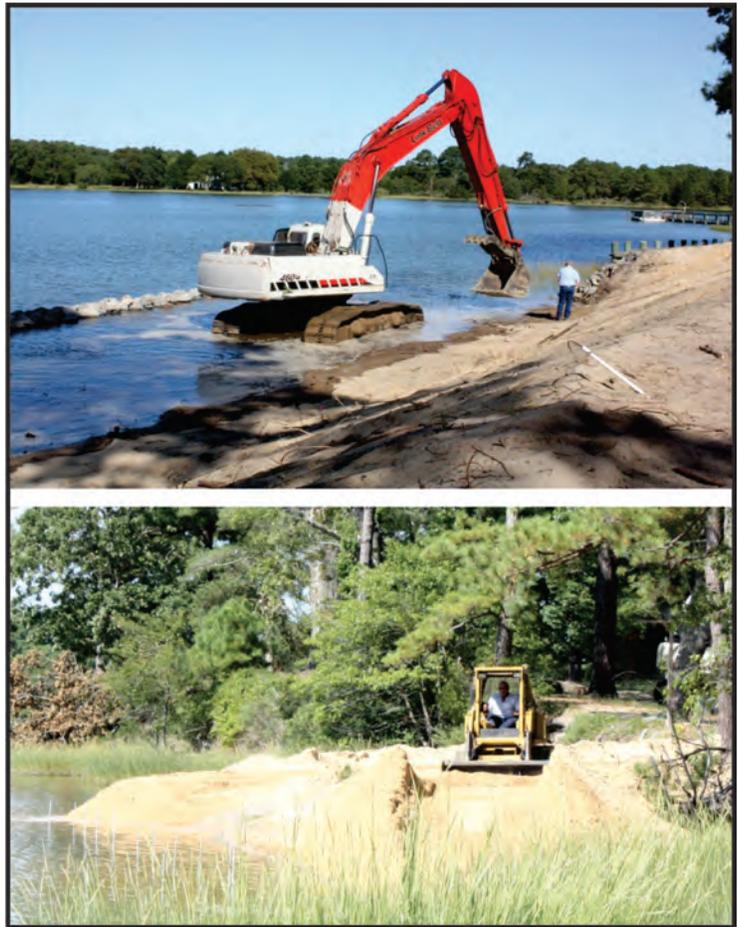
*Figure 5-5. Construction of the shore structures at Occohannock on the Bay.*

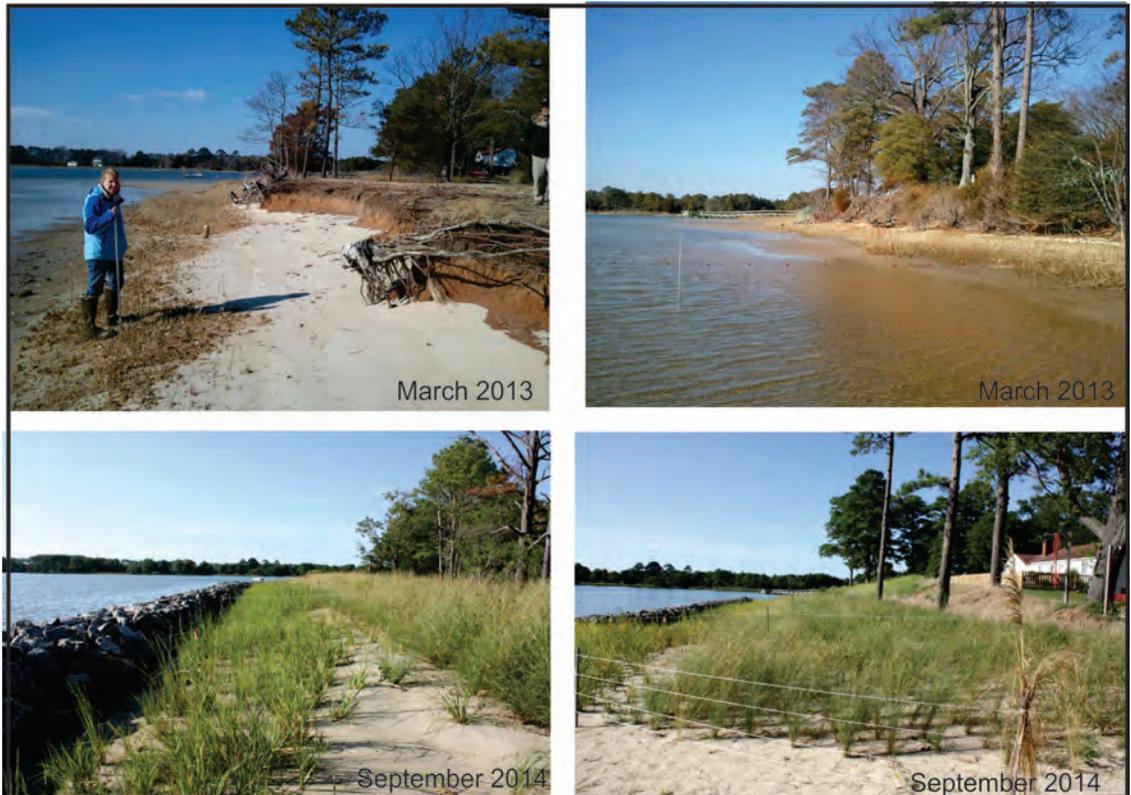
*Figure 5-6. Occohannock on the Bay shoreline before (top) sill construction and after (bottom) construction.*

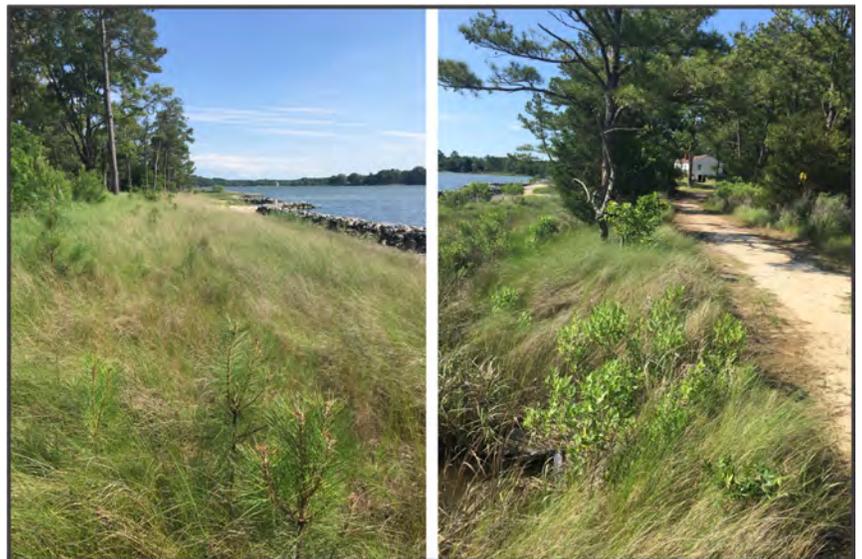
Figure 5-7. Photos of the project three years after installation in May 2017. The marsh behind the sill is expansive (left) and the access road is no longer threatened (right).

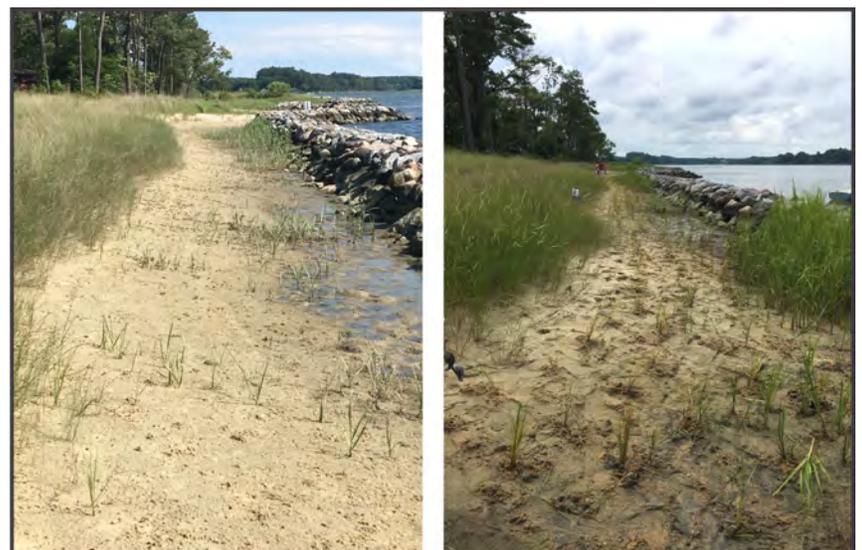
Figure 5-8. Photos showing a bare spot behind the sill (left) in May 2017, and the grasses replanted in July 2017 (right).

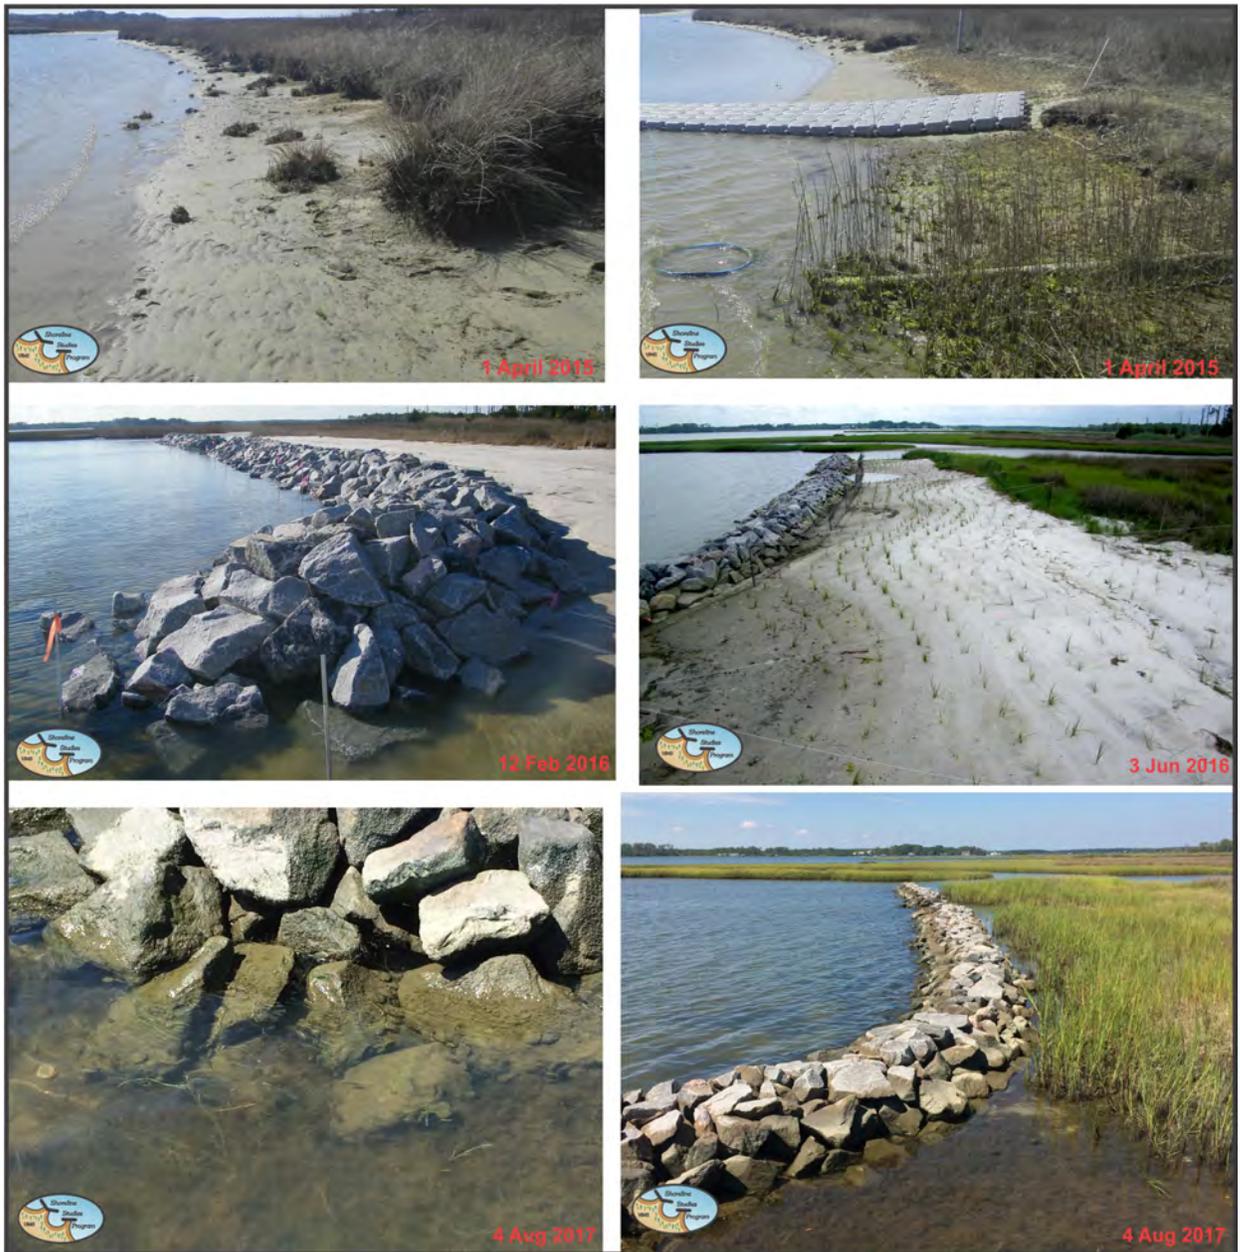
**Figure 5-10.** Captain Sinclair's Recreational Area pre-construction (top), post-construction (middle), and a year later (bottom). The marsh grasses are lush, SAV has grown behind the structure, and fauna are utilizing the rocks and the marsh.

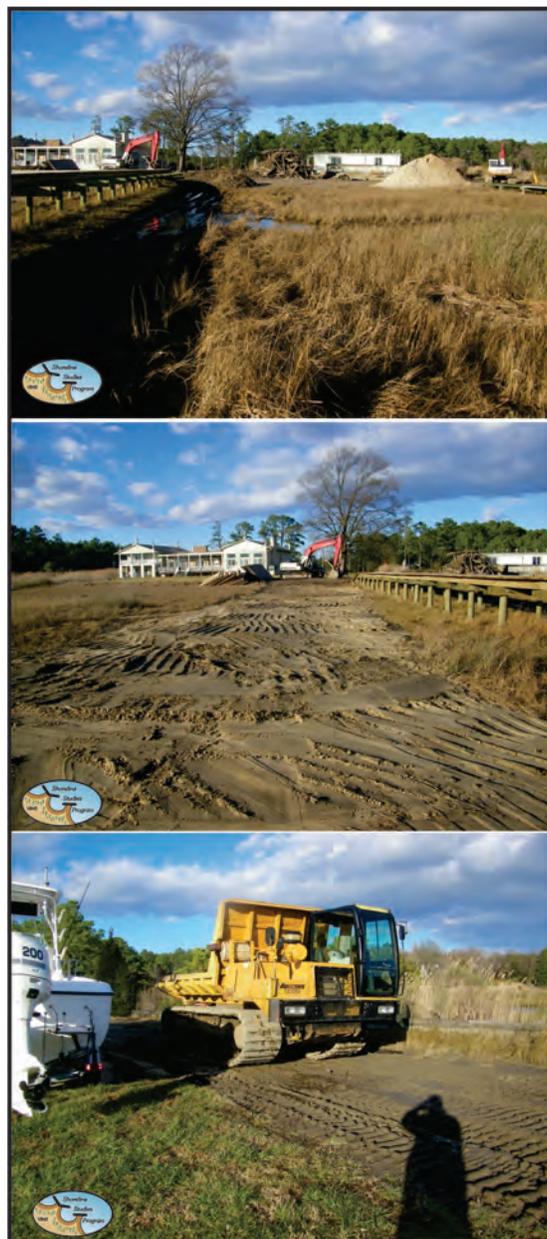
Figure 5-13. Photos taken during construction at Captain Sinclair's Recreational Area on 29 Jan 2016.
