North Carolina's Terminal Groins at Oregon Inlet and Fort Macon

Descriptions and Discussions

Oregon Inlet Terminal Groin

Beaufort Inlet/Fort Macon Terminal Groin

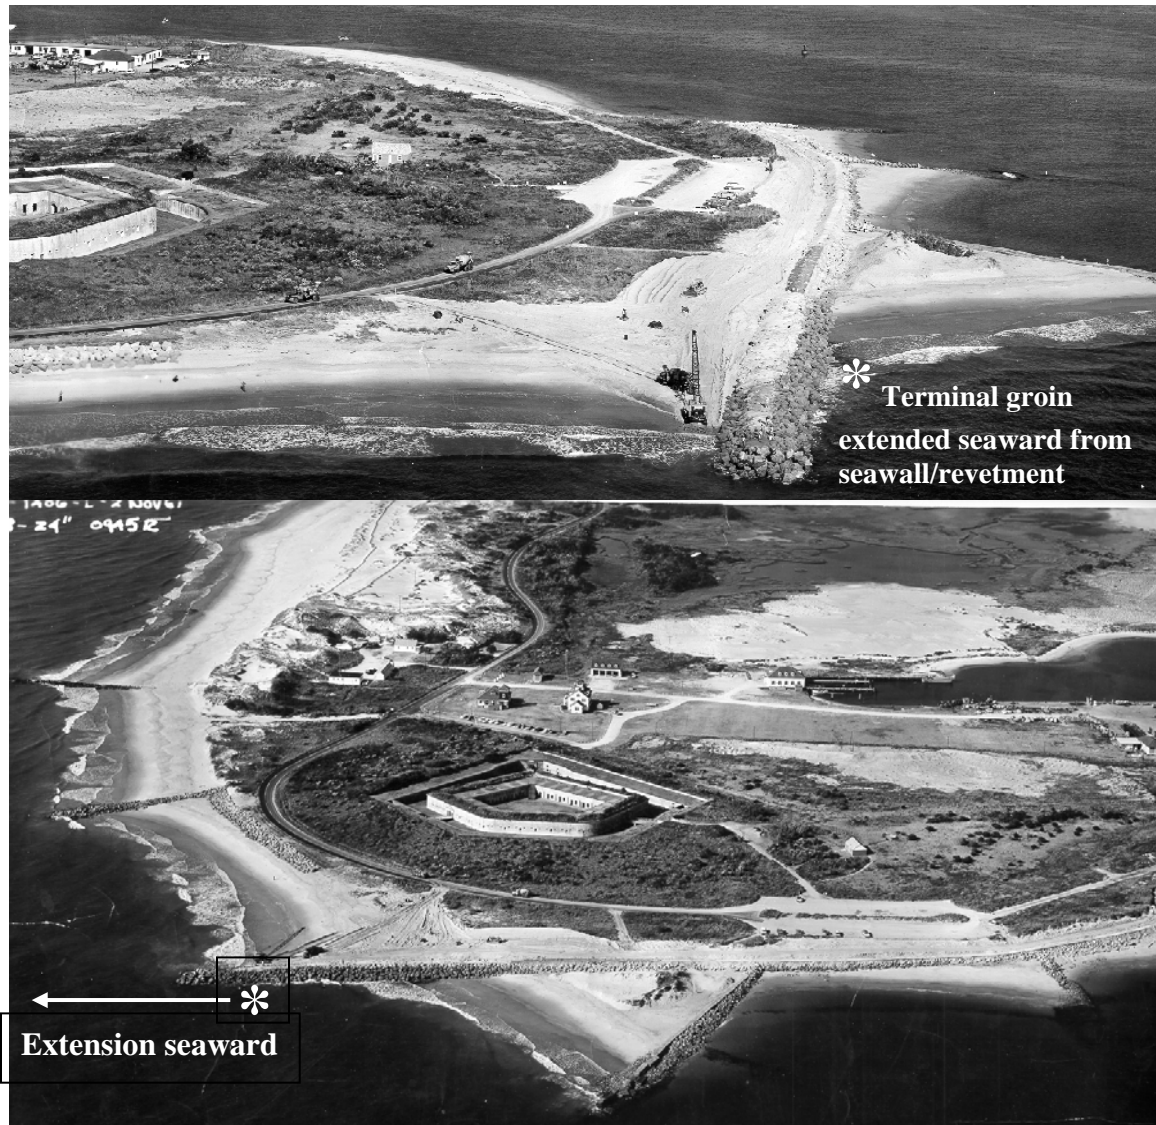
Figure 6. Picture of Fort Macon terminal groin under construction from Nov 1961, and showing all the hard structures placed around the perimeter to try and offset the shoreline erosion.

connecting the Atlantic Ocean to the waterways of the NC State Ports' Morehead City (MHC) harbor and the Town of Beaufort (Figure 5). Improvements for navigation at Beaufort Inlet began in 1911 when a 300-ft wide channel was dredged through the ebb tidal shoal to a depth of -20 ft. In 1936, the outer bar channel was deepened to -30 ft and widened to 400 feet, and the channel location became fixed at this time. In 1997, the channel was dredged to -47 feet and 450 feet wide along the outer channel for approximately 2.5 miles. Interior channels and the Port of MHC are maintained at -45 ft depth. Since 1911, the navigation project channel depth and width has steadily increased, hastening the erosion along Beaufort Point (western side of inlet). Property in this area includes the historical Fort Macon, which was incorporated into the State Park system in 1924. In 2007, 1.2 million guests made the park the most visited State Park in the State. Erosion control structures have been a common occurrence adjacent to Beaufort Inlet since the construction of Fort Macon from 1829 to 1834. Around Fort Macon, there have been approximately 25 "hardened" erosion control structures including groins, breakwaters, timber cribbing, revetments, sand-fencing, and seawalls as well as numerous beach nourishment projects ("soft" erosion control). When emplaced, a hardened shoreline was deemed necessary to save Fort Macon from being lost to the sea (Figure 6).

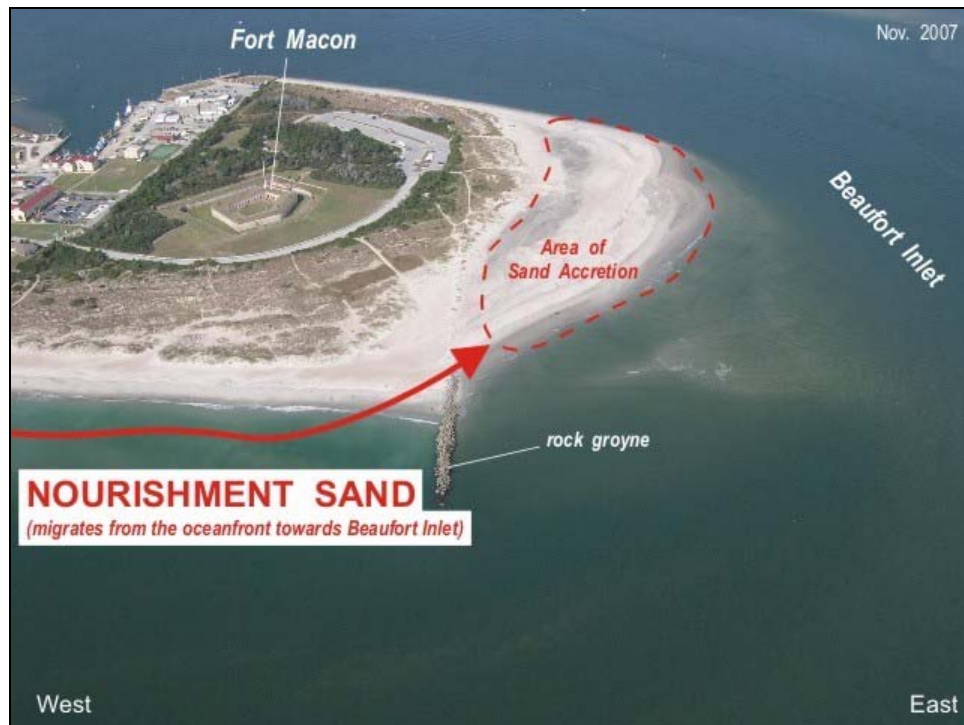
Figure 11. As nourished sand is put on the beach, the sand moves toward the inlet and through the terminal groin to just inside the western edge of Beaufort Inlet.

Prior to navigation improvements spanning 1876 to 1933, Beaufort Inlet was migrating in an eastward direction. During the first 40 years after navigation improvements from (i.e., 1933 to 1974), the migratory trend reversed, and Bogue Banks retreated rapidly back toward its 1876 location. Efforts were made to stabilize the inlet's eastern shoreline and protect Fort Macon with hardened structures. Between 1974 and 1994, beach disposal of inner harbor dredged material has resulted in a fairly stable Bogue Banks shoreline. Since 2004, the sand spit at Fort Macon has advanced along and into the western bank of the navigation channel inside the inlet throat, suggesting the terminal groin is now very inefficient at trapping sediment (Figures 11 and 12).

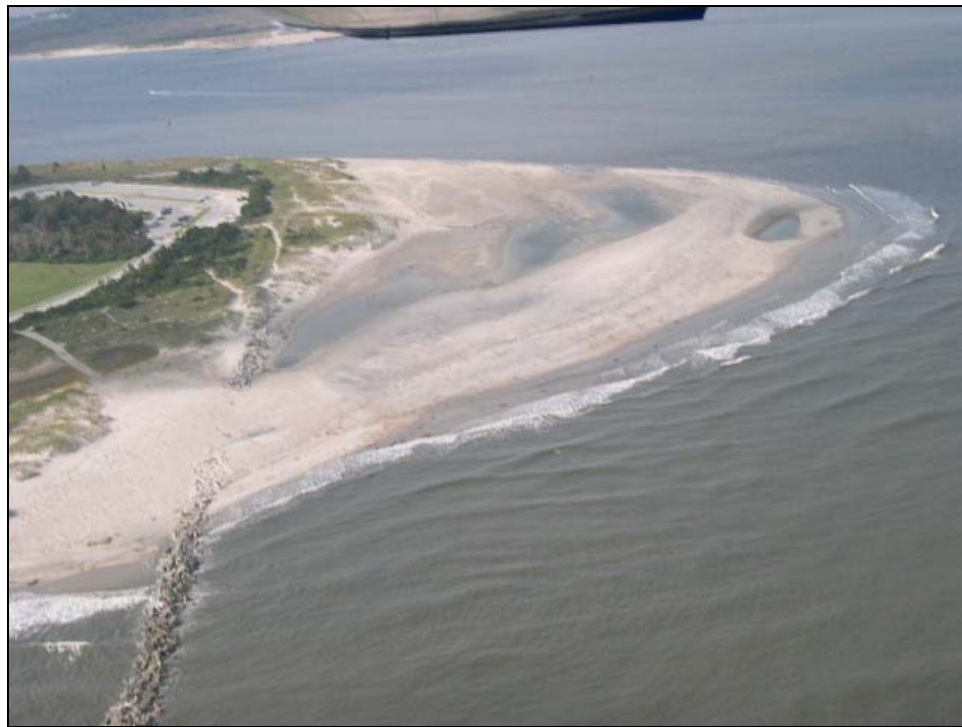
Figure 12. Sand spit growth showing the inability of the terminal groin to trap sediment.
